Curtis Bridge Renovation (#6)

Charl Ross Curtis Bridge Renovation
Draft 2.16.2024
For estimating purposes only—not for construction

Rock Walk Bridge Rebuild (#7)

Sanctuary Path Railing (#8)

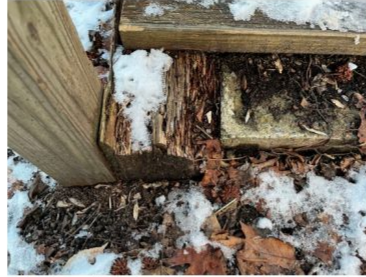
It does not benefit from footings or other means of preventing earth to wood contact, so it has rotted completely on its bottom faces, in particular the two main structural members. It needs to be demolished and disposed of properly, and replaced in kind with a new bridge. The replacement shall be built of pressure treated lumber, and feature footings to support its load and prevent contact with the ground. Its dimensions shall match the existing bridge.

Existing conditions / rotten areas

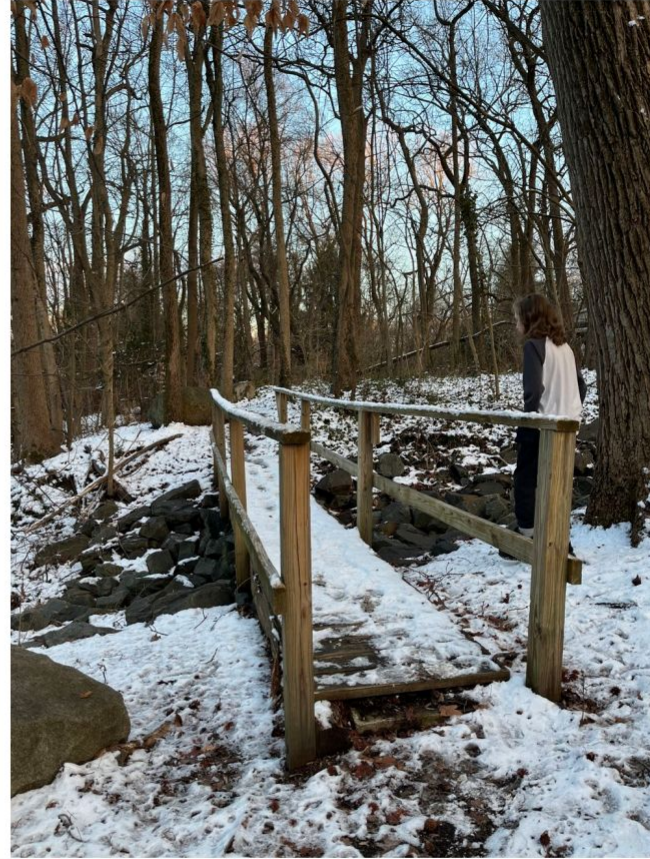
This is a wooden bridge that was built in 2010 as a boy scout project. It spans a small creek and is frequently used by village foot traffic.

Existing conditions / view of bridge

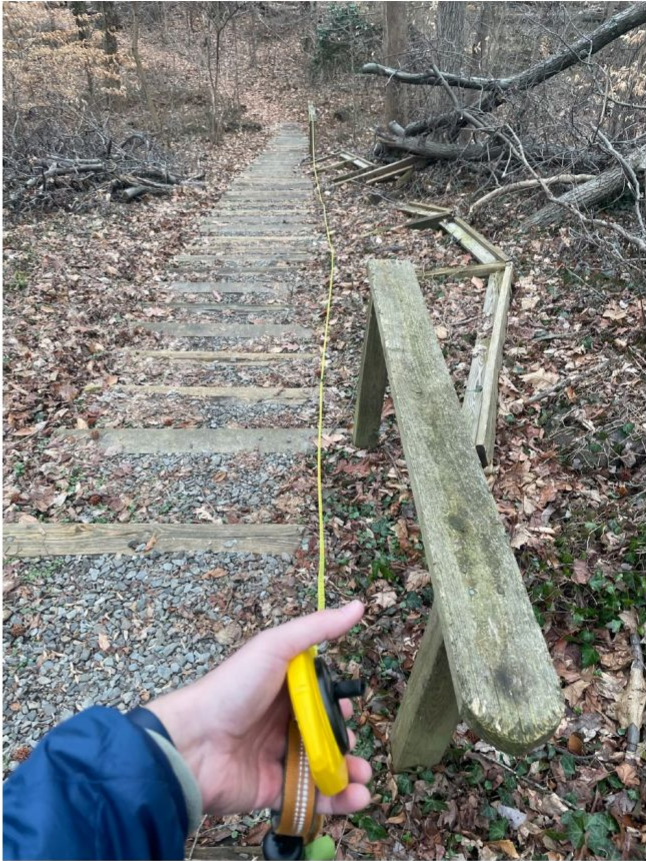
Existing conditions / damaged handrail

This is an older stair that has recently had its handrail destroyed by a falling tree. We request a proposal to remove and properly dispose of the existing damaged posts and handrails, and set new posts with a graspable handrail in approximately the same length (85') as the existing. The posts should be set to 24" below grade with gravel base for drainage, be plumb, and on 8' centers.
